PRESERVATION AND CONSERVATION ASSOCIATION

Volume 14

November-December, 1994

Artificial Siding and Historic Homes

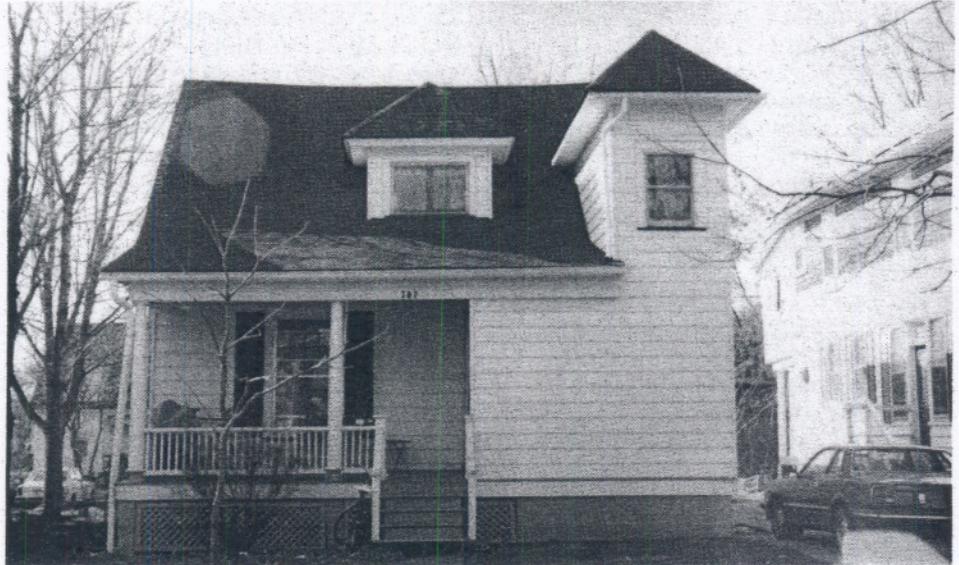
Wide artificial siding changed the historic character of this Urbana house.
